Masonry Saved This Under-Reinforced Building

After finding cracked RC beams, a structural investigation revealed that some main transfer beams had no more than 20% of the required reinforcement

BY YASSER S. KORANY, JOHN I. GLANVILLE, AND GARY S. KOWALCHUK

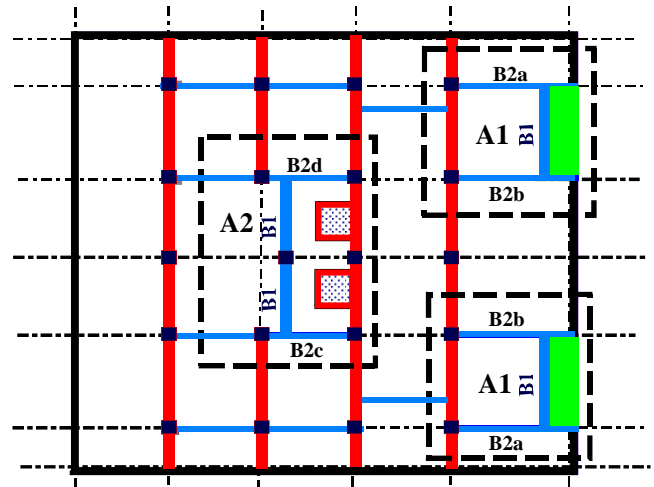
Fig. 2: Locations of concern A1 and A2

At this point in the description of the structural layout, a serious error becomes apparent: a few B1 transfer beams, are supported not on columns or other transfer beams, but on the lesser B2 beams. These B2 beams in the A1 and A2 locations outlined in Fig. 2 should have been more substantial transfer beams similar to the B1 beams. Remarkably, this error was not identified during the various checks made during the design and construction processes.

The locations of concern are identified as A1 and A2 in Fig. 2, with four types of B2 beams, namely B2a and B2b in location A1, and B2c and B2d in location A2. In all instances B2a through B2d, the beam type B1 would have been appropriate, and this was likely the intent of the original structural design. In all four cases, the B2 beams had about 20 to 25% of the resistance required to prevent collapse under the tributary dead load.

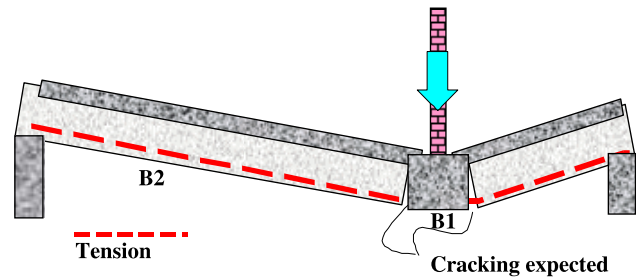
The general configuration of the overloaded B2 beams is shown in Fig. 3. They support the heavily loaded B1

beams at about one-quarter of the span length from one end. Their spans are 7.5 to 10.0 m long, and they are supported at their ends either on the exterior basement wall or on columns. When investigating engineers ran the review calculations, it was clear to them that not only were these beams seriously overloaded, but they actually should have collapsed under the tributary dead load.

The simple collapse mode shown in Fig. 3 would have been the expected behavior. Collapse did not take place, however, although their site inspection showed cracking consistent with serious overloading. Crack widths were 2 to 3 mm wide—about ten times the normal crack width.

Fig. 3: Configuration and expected behavior of B2 beams

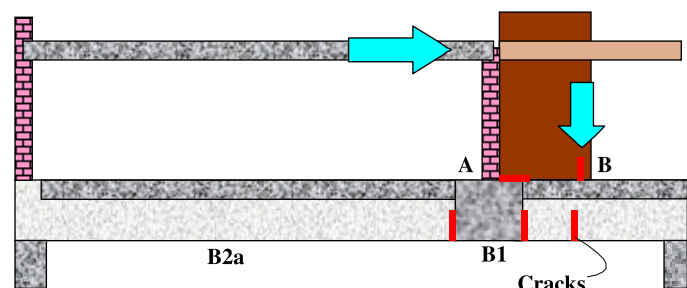
The B2a and B2b beams in location A1 support the heavily loaded B1 beam. The factored design load from B1 was in the order of 850 kN, but the factored resistance to load of B2a and B2b at this location was only about 250 kN. The B2a beams, in addition to the load from B1, support a short length of balcony bearing wall. B2a was, of course, under strength, and the field inspection showed cracking consistent with serious overload and

Fig. 4: Redistribution of loads on B2a

the onset of collapse. To collapse, the beam would have to deflect. As the beam deflected, however, the balcony wall above could not rotate because of the horizontal constraint at the floor levels. This horizontal constraint was provided by the floor diaphragms transferring the required horizontal force back to the vertical service shafts.

As a result of this restraint of wall rotation, the wall separated from the B2a beam at location A and was hung up on the beam at location B (Fig. 4). The validity of this suspected mechanism was borne out by the presence of horizontal cracking at A in the masonry above, indicating separation, and vertical cracking at B, indicating serious overload of the masonry in compression. Fortunately, the masonry contractor, suspecting heavy loads in the short balcony walls, had taken care to grout them fully. The result of this initiating collapse mechanism was to shift the load from the B1 beam out towards the end of the balcony wall, significantly reducing the moment in B2a.

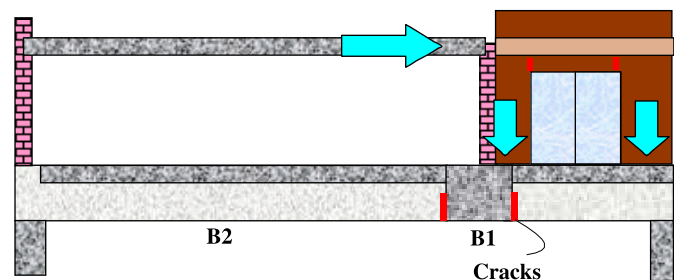
Fig. 5: Redistribution of loads on B2b

The situation for the B2b beam was rather similar in that, again, there was a balcony wall above the beam. This time the balcony wall extended further, but had a large patio-door opening. The balcony wall was prevented from rotating by the floor and roof diaphragms. The walls in this instance redistributed the load by a different mechanism—mainly through the masonry lintels over the door opening (Fig. 5). This was borne out by the presence of cracking in B2b at B1, and by the lintel cracking in the balcony wall. The result was a redistribution of load from B1 toward the support, with a consequent reduction of moment in B2b. Once again, the good grouting of the masonry balcony walls prevented collapse. Interestingly, the masonry contractor cannot recall these balcony walls being bonded with the load-bearing masonry walls. In any case, there clearly was a transfer of load.

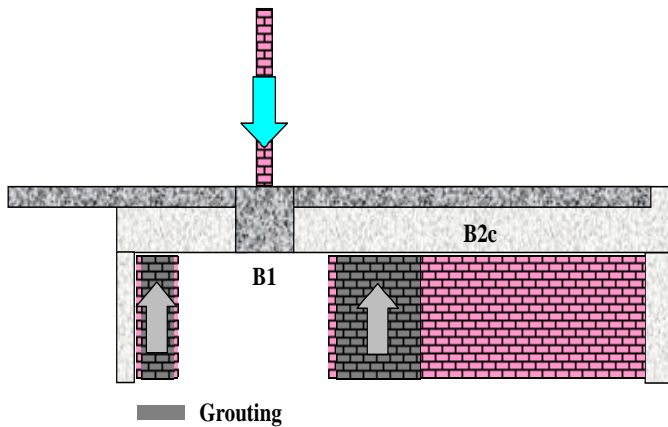
Fig. 6: Redistribution of loads on B2c

Both the B2c and B2d beams were grossly under strength for the reactions from B1. Rather mercifully, there is a masonry wall beneath B2c, which exhibited normal crack widths, and sufficient foundation capacity below. In this instance, it was merely a matter of grouting the masonry wall to sustain the unexpected load safely (Fig. 6).

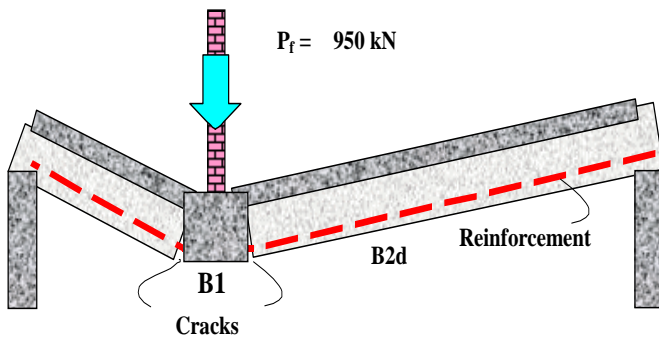
Fig. 7: Loading on B2d

The B2d beam, on the other hand, had some large cracks indicative of yielding steel and effective structural failure. The resistance of the beam to vertical load was 350 kN, compared with a factored design load of 950 kN (Fig. 7).

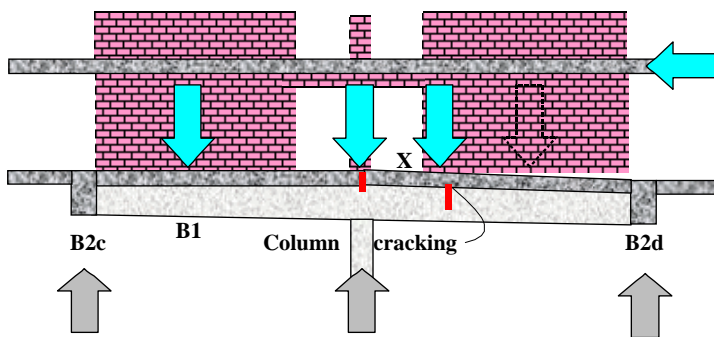
Fig. 8: Redistribution of loads on B1 at location A2

The reason the B2d beam did not collapse can be seen from Fig. 8. Once B2d started to deflect, the wall above B1 became hung up at X, reducing the load transmitted to B2d, but overloading the B1 beam and the foundation under the column.

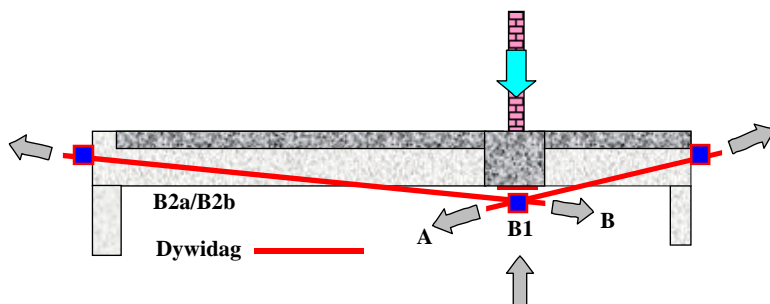
Fig. 9: Remedial work for B2a and B2b beams

Underpinning the B2a and B2b beams was not feasible for two reasons: any columns would interfere with parking, and any underpinning would have to be installed to bedrock at a depth of about 15 m. The engineers

considered attaching steel plates to the underside of these beams, but the number of anchors to be installed was excessive for the space available. Besides, the seriously overloaded masonry walls would not be relieved of any load. For the same reason, strengthening with fiber reinforced polymer composite was not feasible.

The engineers elected to post-tension the under-strength beams with high-tensile Dywidag bars. The repair contractor stressed each 36-mm reinforcing bar to about 700 kN (Fig. 9) to provide the required upward force on each side of each beam. The contractor drilled the concrete walls or beams at each end to receive the bars, which required substantial steel box hardware at each end to sustain the post-tensioning forces. The cost was about \$6700 US (\$10,000 CAN) for each beam.

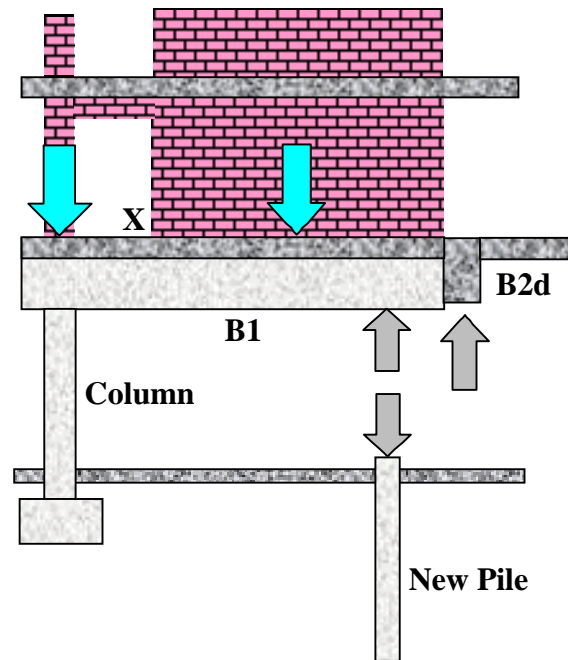
Fig. 10: Remedial work for B1 at location A2

Because B2d was not accessible for the remedial solution used for B2a and B2b, and because headroom was limited for pile installation, the engineers decided a jack-in pile should be installed under B1 about 1.0 m from B2d to relieve the load (Fig. 10). This involved using B1 as the reacting structure while the repair contractor jacked 1.2-m lengths of 300-mm-diameter steel tube one after the other into the clay and welded them together. The cost of the remedial work was about \$13,500 US (\$20,000 CAN).
